Study of the Vaults in the San Martín de Arrieta Church (Vizcaya) after the fire in 2006

Spain /2006
Project data

Structural Type:
Gothic vaults
Location:
San Martín de Arrieta, Vizcaya
Date of Works:
2008
Scope of Works:
Structural evaluation and repair proposal

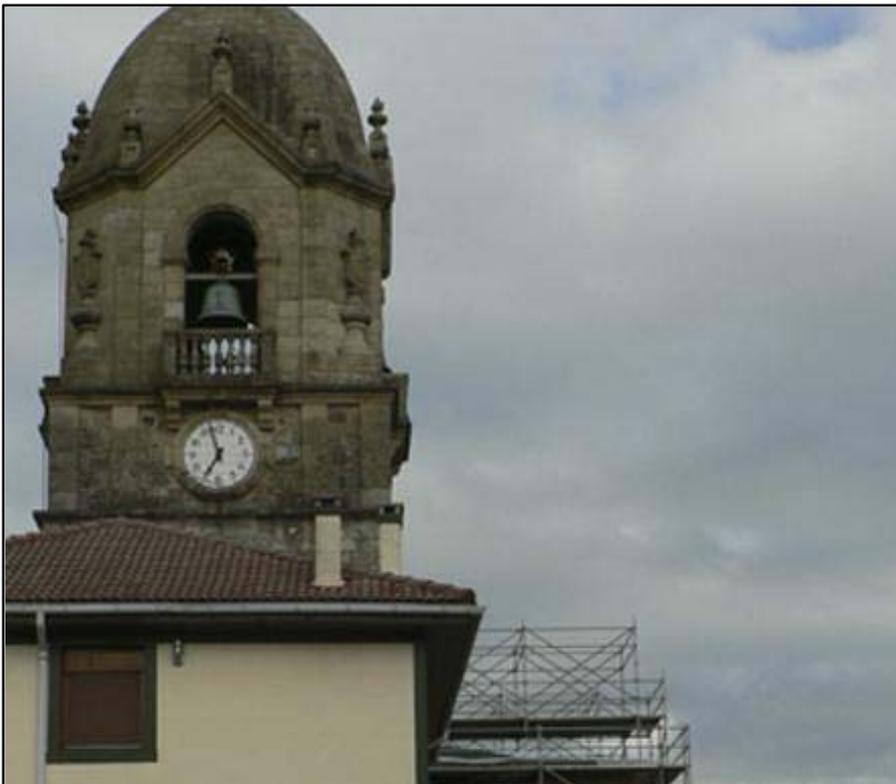
The church consists of a single nave divided into five areas covered by gothic vaults. The fire in December 2006 provoked the fall of the wooden trusses onto the arch transverses which subsequently caused the crown to descend so dragging the vaults down with it.

The analysis of the problem was based on the theories of ultimate state limit, so studying two sets of segments oriented according to the long and short semi-axis which allow the determination that they are stable and that the working loads are moderate. Once the current

situation was checked, a cladding composed of a lime-based mortar and cement low in salts, was proposed as a solution. This would improve the capacity of the vaults against the applied loads as well as offering greater durability.
