Restoration of the Pênsil Bridge

São Vicente, São Paulo, Brazil / 2012

suspension bridge replacement of main cables for structural restoration
main span: 177.60m
Engeti Engenharia

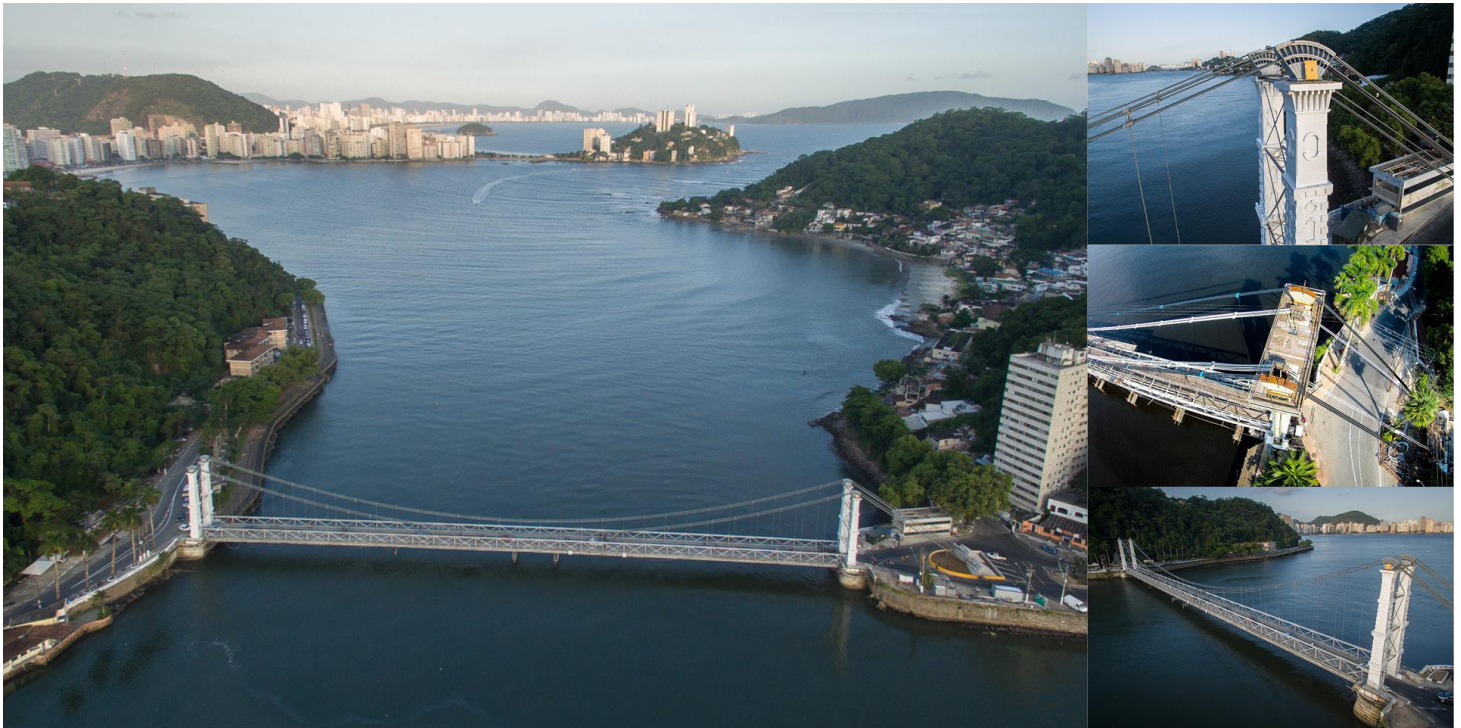
The São Vicente Suspension Bridge was erected in 1914 as part of the sanitation plan of the Santos and São Vicente area. Bridge condition in 2012 was deemed to be critical as some elements in trusses had disappeared and cable shown important corrosion and loss of cross section.

The main factor influencing the cable substitution process was the configuration of the existing cables, which were grouped in two rows of six plus two cables. Being the bridge part of the São Paulo State Historical Heritage, it was mandatory that cables final configuration was similar to the original in number, position and dimensions. Besides this, connections between cables and deck was also to be maintained, this implying the need of fabricating new clamps and saddles as similar as possible to the existing ones.

These requirements determined the proposed construction process, as they implied dismantling the actual cables before installation of the new cables in their final position, and therefore placing a temporary saddle independent of the existing.
