Ponteceso Bridge restoration

Ponteceso, Galicia, Galicia / 2004

masonry arch bridge
refurbishment and deck widening
Xunta de Galicia

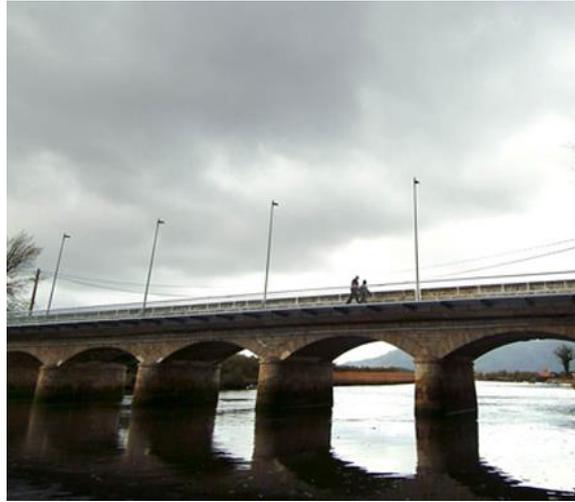
The Ponteceso Bridge is an Ashlar masonry arch bridge erected at the end of the nineteenth century. It is 50.0m long, and is composed of five vaults, spanning 10.0m between pier axis and an 8.50m free span at the maximum points of the barrel. The bridge has four piers which are set in the flow of the river. The vaults are 0.70 m thick and 6.00 m wide. All the bridge was erected in granite Ashlar, which remain in a good state of repair. Piers and abutments are foundationed on wood piles, upon a low bearing capacity soil. The current bridge deck is too narrow to allow road and pedestrian traffic to run smoothly.

Widening of the bridge, now reaching 8.95m, was designed asymmetrically, so that one of the elevation views of the bridge remains intact, thus meeting patrimonial requirements. Widening was fulfilled using a concrete slab on top of the bridge's back. The slab is 7.05m wide and 0.30m deep, and will bear road traffic. A gridded steel walkway, resting on steel ribs spaced every 2.0m and connected to the slab, will support pedestrian traffic. The steel ribs are connected to the slab without affecting or touching the spandrel walls, resulting in a cantilever length of 3.47m.

Foundation strengthening consisted in the drilling and execution through piers and abutments with micro-piles, crossing through the aforementioned soil layer, reaching subjacent rock strata.
